RE : U.S. Nuclear Regulatory Commission Information  
Notice 2005-27 "Low-Dose-Rate Manual Brachytherapy  
Equipment Related Medical Events"

DATE : October 24, 2005

NRC INFORMATION NOTICE 2005-27: LOW-DOSE-RATE MANUAL BRACHYTHERAPY  
EQUIPMENT-RELATED MEDICAL EVENTS

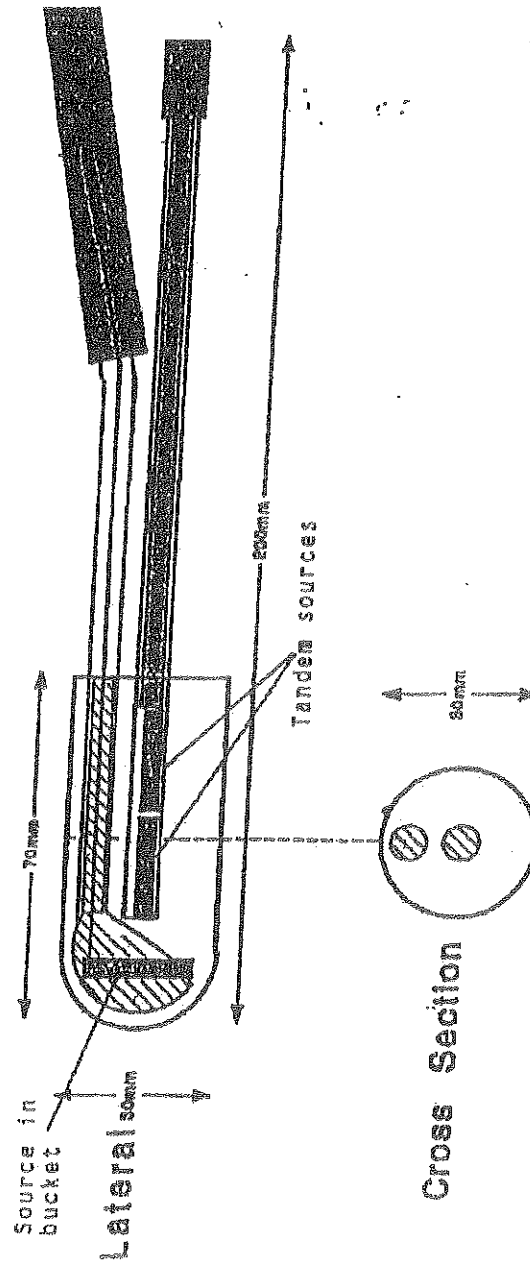
Attachments: 1. Diagram of Wang Applicator  
2. List of Recently Issued NMSS Generic Communications

The applicator involved in the five medical events was a Mick Radio-Nuclear Instruments, Inc. Wang Front-Loading Vaginal Applicator, Model 8524 (applicator), intended for use with cesium-137 sources, to treat patients. See the attached diagram of the Wang applicator. The instructions provided with the applicator specified the use of sources manufactured by the 3M Company (3M), and the applicator was marked with the appropriate source dimensions.

During each of the first five brachytherapy treatments performed by the licensee with the Wang applicator, that resulted in medical events, licensee staff selected G.E. Healthcare (formerly known as Amersham; hereafter referred to as Amersham) sources for use in the tandem portion of the applicator. The Amersham sources were different in a critical dimension from the 3M sources specified in the instructions - they were too small in diameter, being 2.6 millimeter (mm) (0.10 inch) in diameter, when 3.1 mm (0.12 inch) diameter sources were specified. As a result, the tandem sources slid down to the opposite end of the applicator's flexible carrier tube whenever the applicator was tilted more than 20 degrees off-level (i.e., the tandem sources moved out of their intended position whenever a patient moved more than 20 degrees off-level (e.g., sat up) during treatment), resulting in irradiation of the skin on the patient's thighs. The Amersham sources moved through the center of the applicator's carrier tube spring because the diameter of the sources was smaller than the inner diameter of the coil spring.

- Instructions did not clearly alert the user to proper action that must be taken if the spring in the tandem portion of the applicator required shortening. The distal end of the applicator coil spring was designed with an inward bend, to prevent source movement down the center of the spring. The instructions stated that the applicator spring could be shortened. This would be necessary if more than two sources were used in the tandem portion of the applicator. The instructions did not provide a warning to the user not to cut the distal end of the spring with the inward bend, if shortening of the spring was necessary. Such an action could result in source movement down the center of the spring.

The licensee had not used more than two sources in the tandem portion of the applicator for any of the five similar brachytherapy treatments completed. Therefore, the licensee did not cut the applicator spring. However, the spring supplied with the licensee's applicator did not include the inward bend at the distal end, which increased the potential for source movement under certain circumstances. The Amersham sources could, and did, for the five patients involved in

licensee modified the applicator by using different hardware to keep the radioactive sources in proper position during brachytherapy treatments. The licensee's modification of the applicator was effective.<sup>1</sup> However, the licensee misinterpreted the medical event reporting requirements in 10 CFR 35.3045(a)(3) and failed to promptly identify, in April 2004, that multiple medical events had occurred. Reporting of medical events (2) to NRC was delayed until March 2005, when, following patient reexaminations, the licensee determined that treatment side effects for two patients were more severe than previously observed.

- Assure that radioactive sources and any other ancillary devices to be used with an LDR manual brachytherapy applicator for a therapeutic procedure are designed for use with, or are known to be compatible with, the LDR applicator to be used during the procedure;
